Preliminary Study of Electronic Replacement Compasses for the Army

by Bruce R. Geil

ARL-MR-223

November 1995

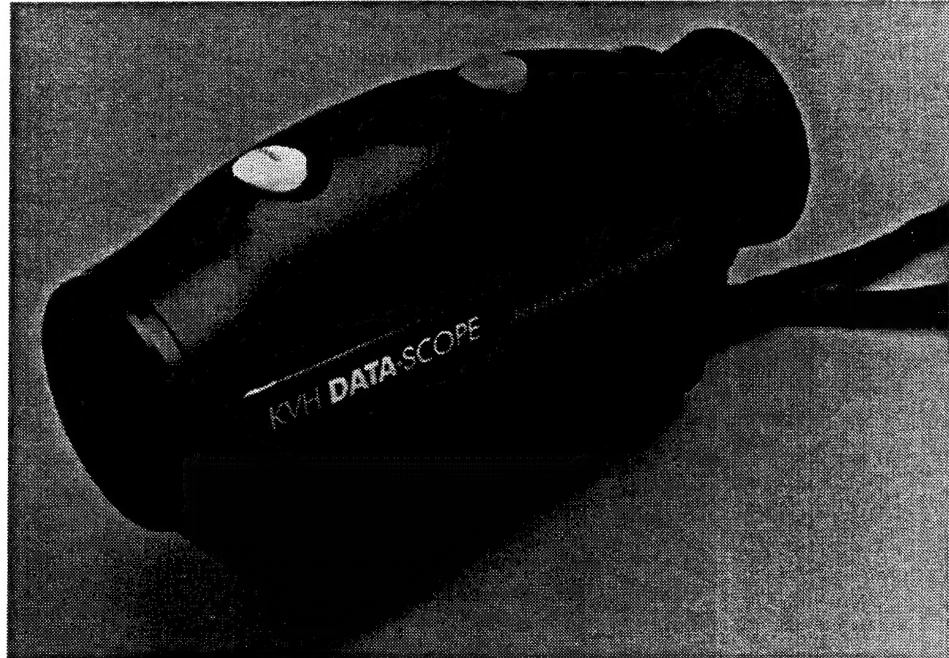
Figure 7. KVH DataScope.

For this study, we tested three different electronic compasses. The first is the KVH DataScope (see fig. 7). This compass consists of a 5×30 monocular used for sighting, a flux-gate sensor, and associated electronics. This compass differs from the present lensatic compass in the way that it obtains sights. The lensatic compass uses a thin-line sight to target an object. The compass coordinate is then read using a magnifying eyepiece. The coordinates can be obtained in degrees or mils, depending on need. To obtain a reading with the DataScope, the unit is first turned on and, if necessary, calibrated. This calibration is normally only required after battery replacement. The user sights through the 5×30 monocular, and the bearing is displayed in the monocular using an LCD display. This compass does allow for both mils and degree readings, and can store up to 10 different

bearings. It also has the ability to store chronometer readings with the bearings, thus allowing speed calculations to be performed. One other feature of this compass is the built-in rangefinder that uses known heights and relative size to find the range of an object.
